intel® Technical Advisory

TA-668-3

October 10, 2003

Intel® Server Chassis SR1300 SCSI Hot-Swap Backplane Incorrect Crystal

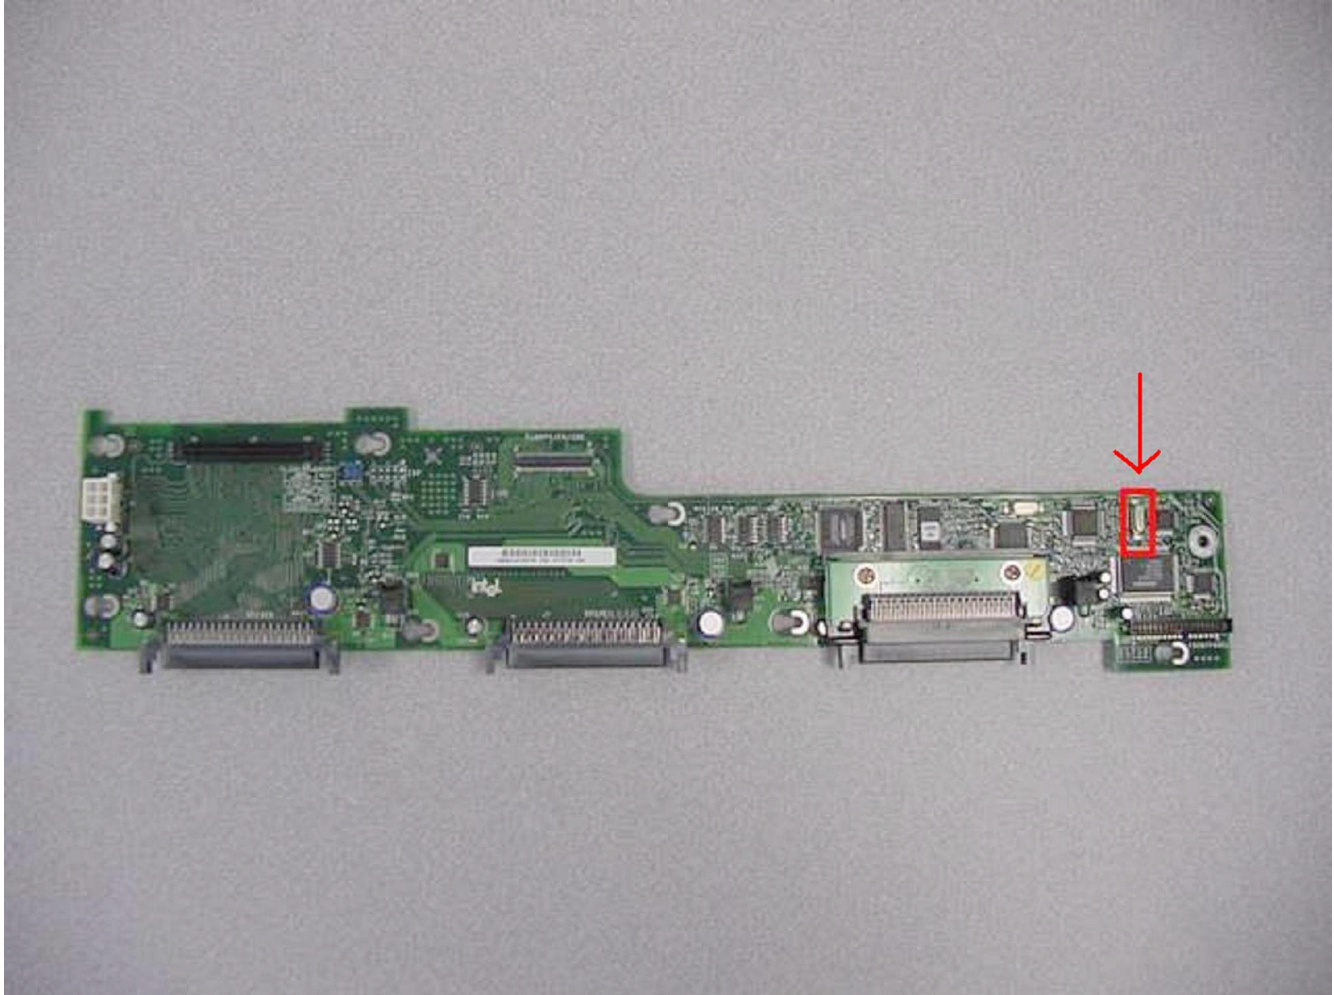
The SCSI Hot-Swap Backplane design requires use of a fundamental 40.0 MHz crystal. Failing SCSI Hot-Swap Backplanes were built with 3rd overtone 40.0 MHz crystals from a single vendor instead of fundamental 40.0 MHz crystals.

- ❖ Visual inspection is require at this point if customer is using a SAF-TE RAID configuration of the crystal in location Y2
 - Crystal marked with "40.0[N] XXXX ARE affected. The XXXX is a date code related marking

1. Remove the lid from the Intel Server Chassis SR1300 (for systems that have already been integrated).
2. Remove the system fan pack from the Intel Server Chassis SR1300 (for systems that have already been integrated).
3. Find the crystal (silver colored) at location Y2 on the SCSI Hot-Swap Backplane (PBA A77570-202). The crystal location is shown in the following two photographs below.
4. Crystals marked with "R400 XXXX" are NOT affected by this issue. Crystals marked with "40.0 [N] XXXX" are affected by this issue. In both cases, the XXXX markings are date code related and may be different, however, these date code markings are not significant to this issue.

Intel has removed all of the 3rd overtone crystals from manufacturing and is building new product with fundamental 40.0 MHz crystals. Intel has screened all inventory for this issue. All Intel Server Chassis SR1300 chassis products, spares, and accessory kits shipped after September 12, 2003 will have the correct crystal. Intel is adding a light-colored sticker to the shipping label on the shipping box for Intel Server Chassis SR1300 chassis products, spares, and accessory kits with serial number workweeks between 27 and 36 that have been screened by Intel for this issue.

Customers who have material affected by this issue should obtain replacement product through normal warranty procedures. To get parts contact Intel using your normal warranty process. Please indicate that you are calling regarding TA number 668-3, and have the following information when you call; the part number requested, and the serial number(s) for the system(s) or board(s) needing the replacement part.
