intel[®] Action Alert

AA-0748-1

February 2, 2005

Intel[®] Server Board SE7520JR2 DDR2 MCH VR Circuit Component Failure

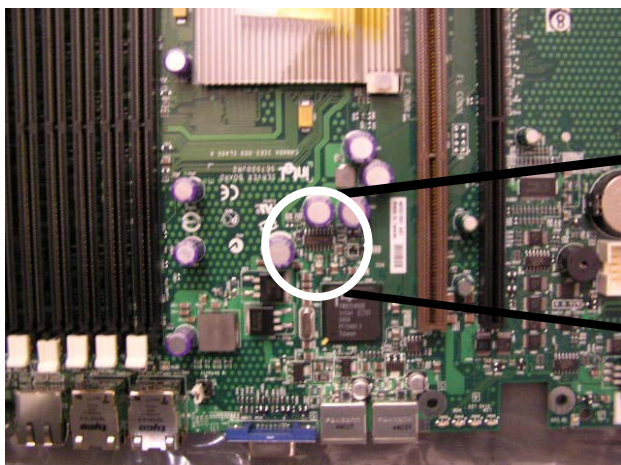
Failure analysis for this issue revealed that on some boards, an anomaly was found with the 1.8 Volt regulator circuit within the DDR2 memory sub-system, where a VR controller showed improper operation producing excessive voltage on the 1.8 Volt rail. This over-voltage condition results in the destruction of the MCH, a FET, and DIMM.

To identify a SE7520JR2 DDR2 board susceptible to this issue, locate the L6910 VR controller chip at board location U6C1 as shown below. **Boards that have a VR controller chip with a white dot "•" silk-screened after the L6910 part number ARE SUSCEPTIBLE to this issue and should NOT be used.**

Boards that have a L6910 VR controller chip with no dot are not susceptible to this issue and can be used.

dot "•"

Customers should screen all existing SE7520JR2 DDR2 product (boards and systems) **that have serial number date codes prior to those noted above** for the following board identifier. Boards found with the identifier should be returned to Intel for immediate replacement.
