# intel® Technical Advisory

TA-0592-1

Aug 22, 2002

## SPSH4 Missing FRU Data in Power Supply

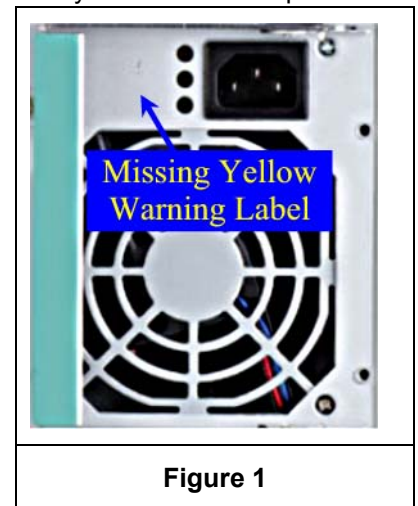
Twenty-six SPSH4 accessory/spare power supplies (product code AC3POWER) were shipped from the Intel® factory with missing FRU data and missing labels. The affected power supplies were only shipped as spares and none of them were integrated into SPSH4 server platforms at the Intel® factory.

The affected SPSH4 power supplies can be identified by a missing yellow warning label on the back of the power supply. Please see Figure 1 for the location of this missing label.

This issue is root-caused to an Intel® supplier; corrective action has been implemented in the Intel® factory and at the supplier location.

Although these power supplies functionally deliver power, because the presence of these power supplies can not be automatically determined, Intel® recommends that these power supplies be returned for replacement via normal service procedures.
