Manually Ejecting a Cartridge and Identifying Cartridges that Cause Eject Failures

1 Introduction

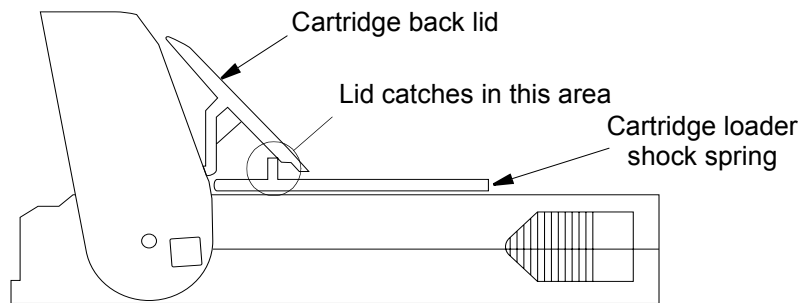
A small feature on the back lid of cartridges from the affected supplier can catch on the vertical tab of the early version of the cartridge loader's shock spring (see the following figure). When this occurs, the tape drive cannot eject the cartridge. The tape drive posts an FSC ADh error.

Note: The feature is not visible without disassembling the cartridge. All cartridges from this supplier are within manufacturing and ECMA specifications. The cartridges eject properly when used in tape drives with the newer design cartridge loader.

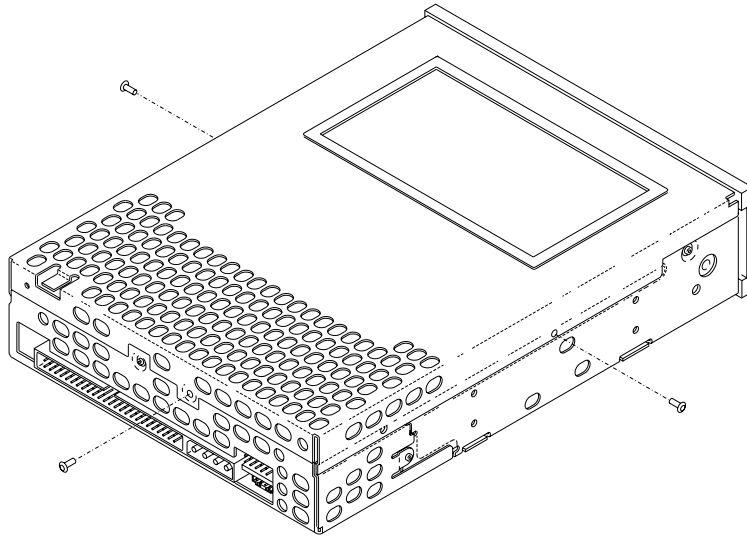
1. Remove the screws on the right and left of the tape drive, then remove the screw on the back, as shown in the following figure.
2. Slide the cover back about one-half inch (1.3 cm).

3. Place your fingers under the front of the cover and lift the cover off.

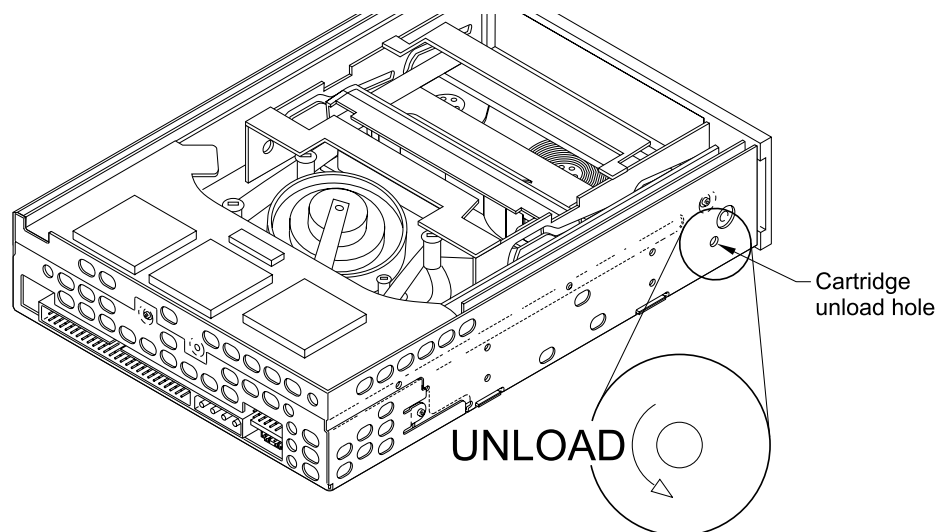
1. Locate the cartridge unload hole on the left side of the tape drive, as shown in the following figure.

2. Insert the ball Allen hex driver into this hole approximately 0.65 inches (16.5 mm), guiding it through a hole in the circuit card until it mates with a plastic connector.
3. Turn the driver in the direction of the arrow in the above figure to eject the cartridge from the tape drive.

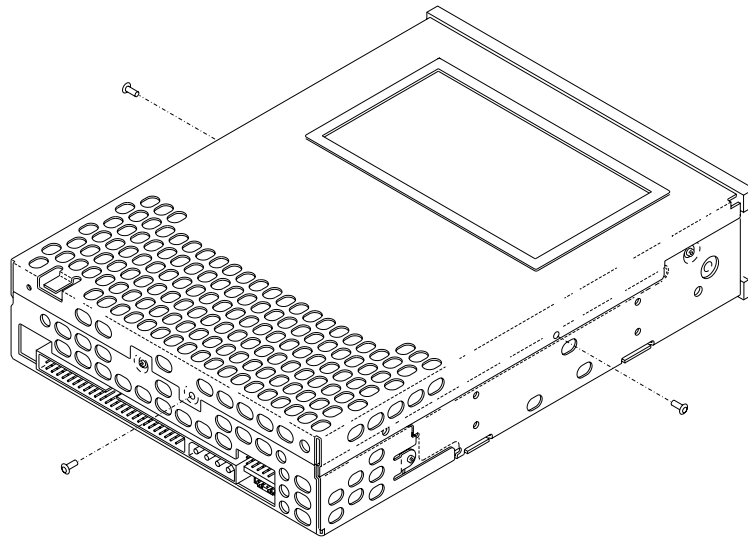
1. Replace the tape drive cover and slide toward the front of the drive about one-half inch (1.3 cm).
2. Reinstall the screw on the back, followed by the screws on the right and left of the tape drive, as shown in the following figure.
