December 1998
ECG033/1298

Compaq Computer Corporation

Compaq ProLiant 6000/7000 Pentium II Xeon Migration with Windows NT 4.0 Installed

Abstract: The purpose of this white paper is to provide tested server information to successfully migrate using the ProLiant 6000 or 7000 Pentium II Xeon upgrade kit on servers running Windows NT 4.0.

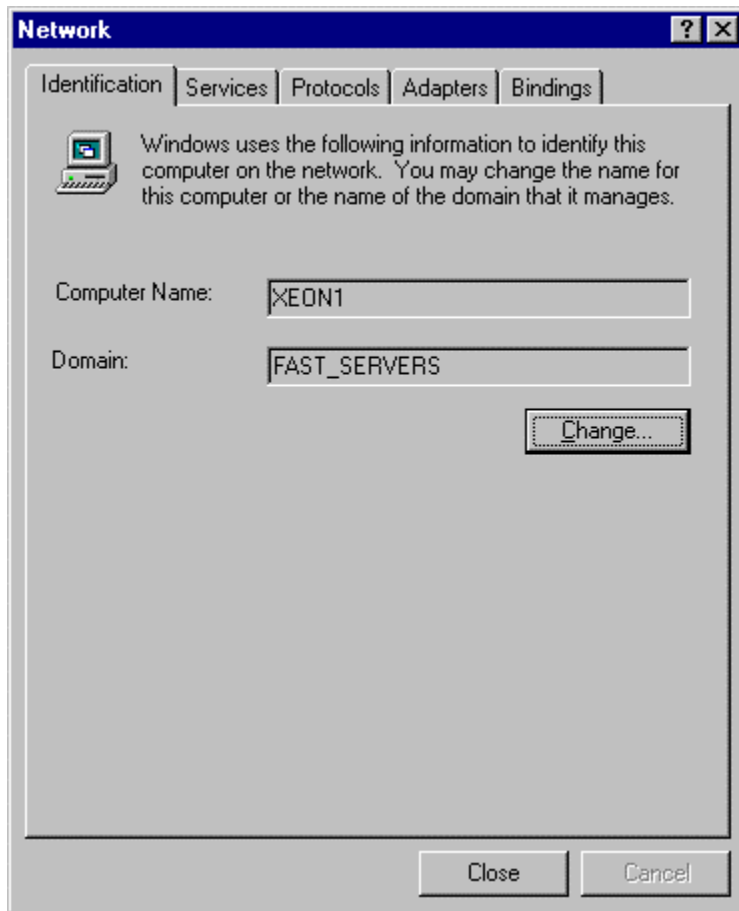
1. Click Start→Settings→Control Panel→Network icon.
2. Select the Identification tab.
